JONES RIVER BASIN
ISAAC BRANCH, KENT COUNTY
DELAWARE

WYOMING LAKE DAM

DE 00034

**PHASE 1 INSPECTION REPORT
NATIONAL DAM SAFETY PROGRAM**

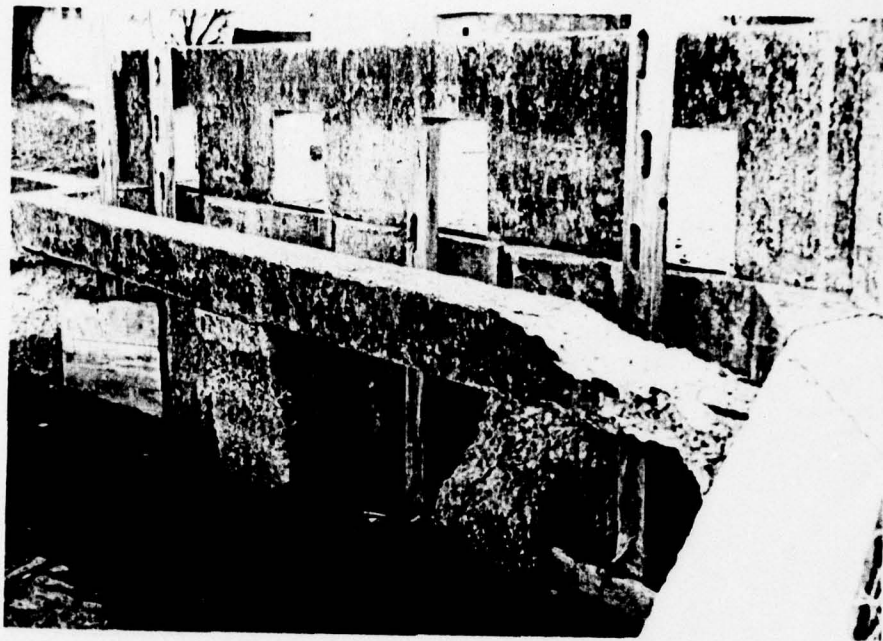
PHOTO 1
Mill Road Dam

- Photo 1 - Closeup view from upstream of Wyoming Lake Road Dam. Note: Damaged concrete beam, shortened lifting stem (center) and stoplogs out of guide paths (left side).

- (1) The deteriorating stoplogs should be replaced.
- (2) The wall dividing the mill race downstream should be repaired or replaced.

d. The deteriorated trash control at the Mill Road spillway and the deteriorating trashrack at the mill raceway should be repaired or replaced within one year from the date of approval of this report.

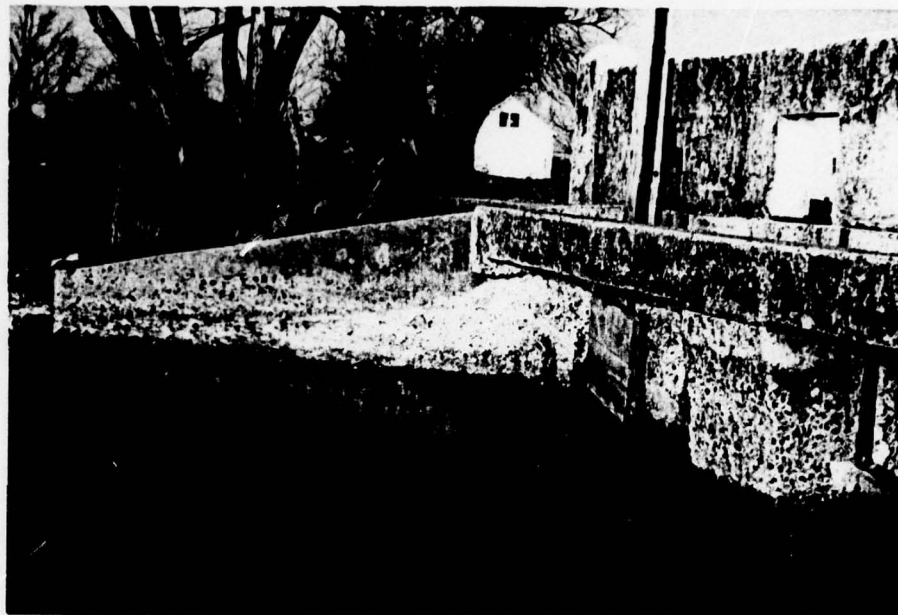
PHOTO 3
Mill Road Dam

- Photo 3 - View of upstream inlet south side wingwall & damaged inlet gate out of guides. Note: Trees growing on embankment side and general spalling of concrete.

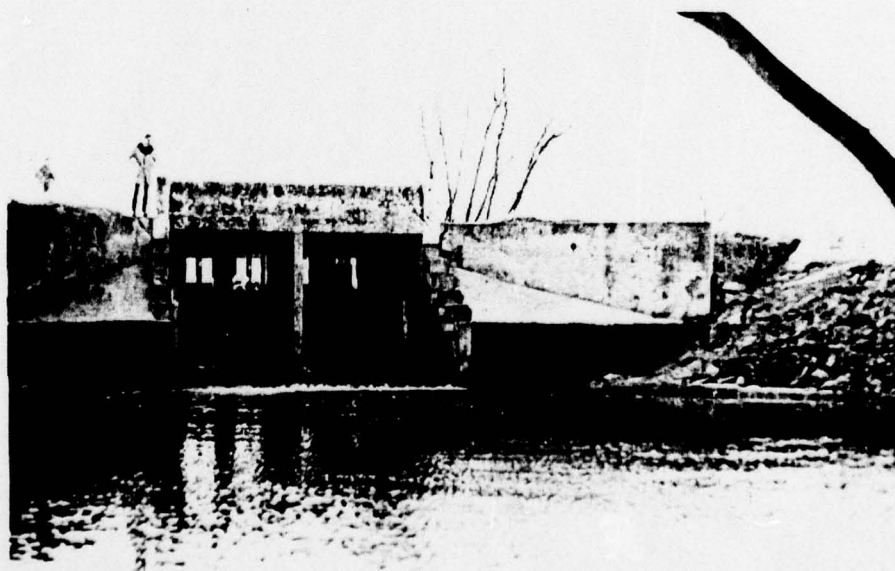
PHOTO 4
Mill Road Dam Outfall-Downstream

- Photo 4 - Downstream view of Mill Road Dam outlet area
Note: Concrete apron between wingwalls, metal sheet piling and broken bituminous material on earth embankment slope.

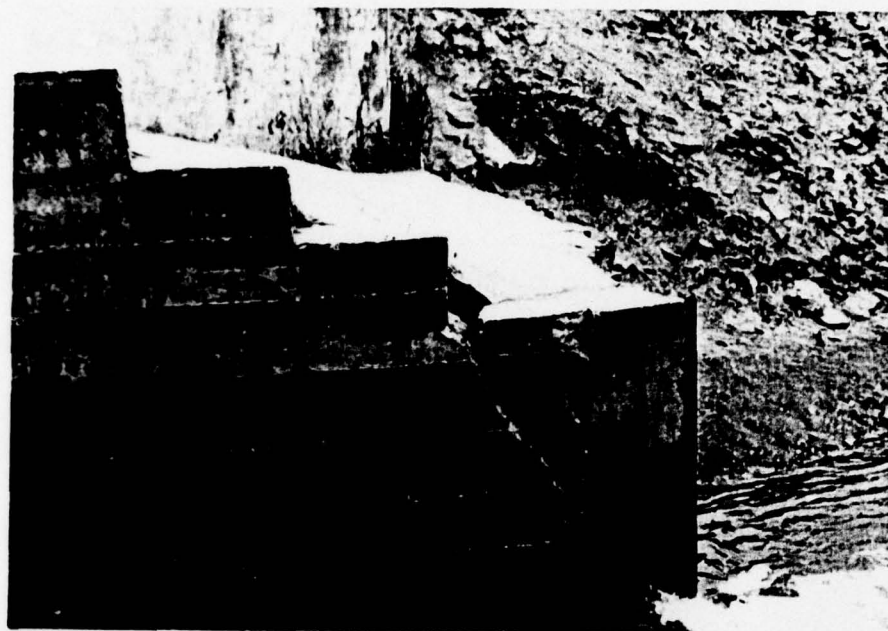
PHOTO 5
Mill Road Dam - Downstream

- Photo 5 - Closeup view of south side downstream wingwall Mill Road Dam to show cracked condition that could indicate possible sheet piling tie back failure.

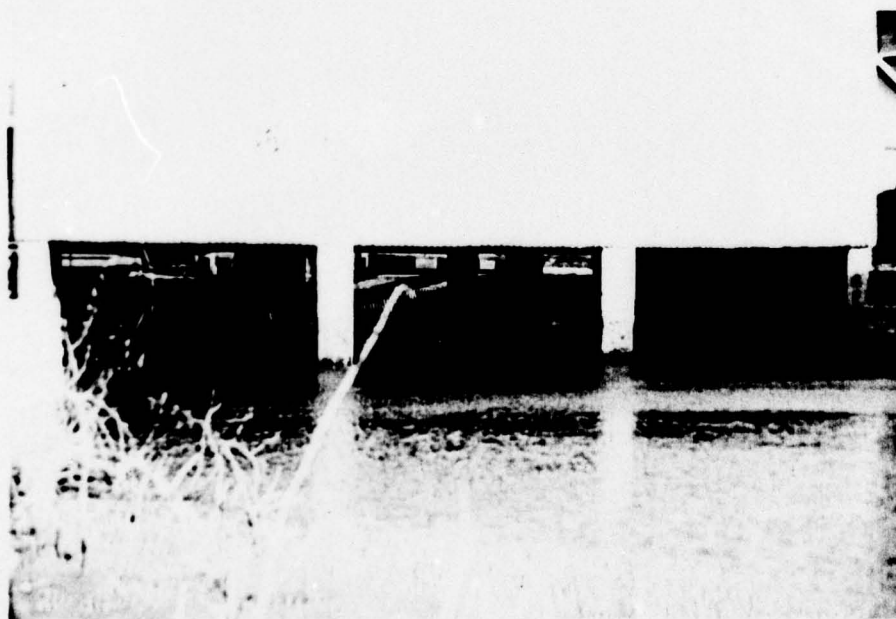
PHOTO 6
Mill Race Dam-Appurtenant Bldg.

- Photo 6 - View of Mill Race inlet area showing appurtenant building over top of inlet area. Note spalling of concrete support posts.
- Photo 7 - Closeup view of Mill Race inlet showing condition of trash rack and stoplogged lift gates. Note: condition of wooden guides, lifting stems.

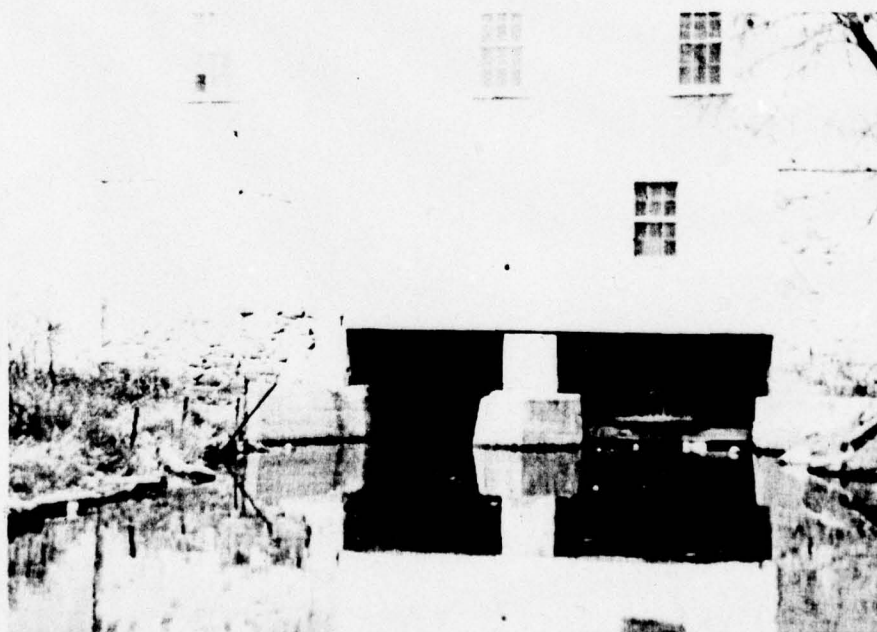
PHOTO 8
Downstream-Mill Race Outlet

- Photo 8 - Downstream view of Mill Race outlet. Note: Blocked sluice on left (north) side and mortared stone construction of building.
- Photo 9 - Closeup of downstream Mill Race outlet structure.
Note: Center wall pier shows no sign of deterioration on outside - deterioration is existing under the Mill; however, it could not be photographed due to lighting conditions.

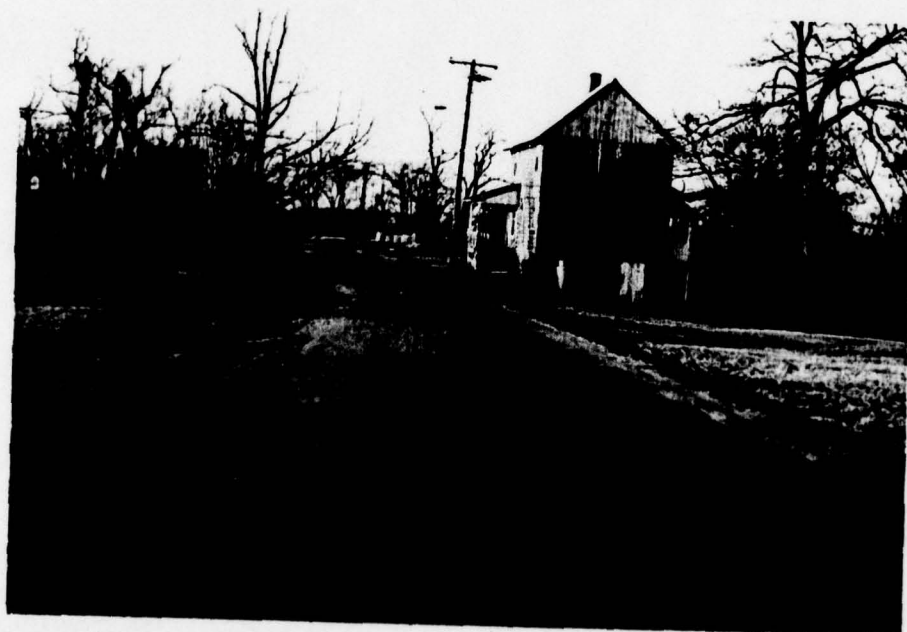
PHOTO 10
Dwelling on Embankment South of
Mill Road Dam

- Photo 10 - View of embankment crest, road and residential home (occupied by two people) located on the west side of the embankment crest. Note: Elevation of house first floor (rear porch elevation).

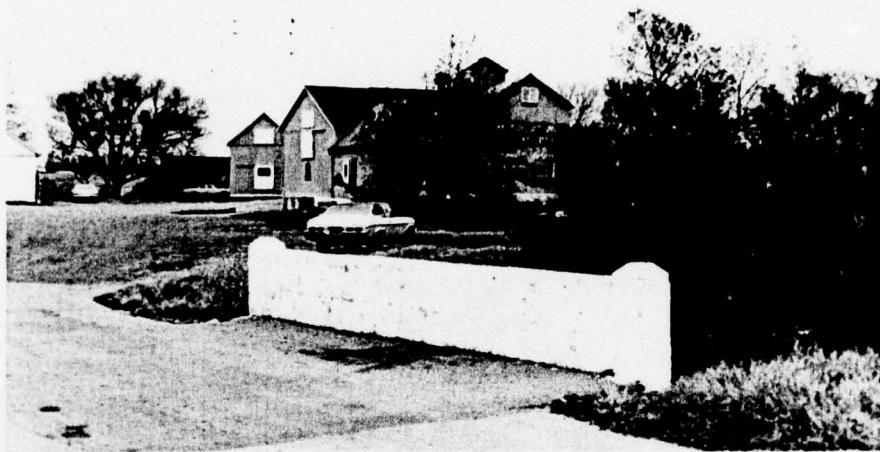
PHOTO 11
Mill Buildings

- Photo 11 - View of widened embankment over Mill Race and of the Mill buildings.
- Photo 12 - View of downstream Mill Race channel and peninsula separating the Mill Race downstream channel from the Mill Road downstream channel.

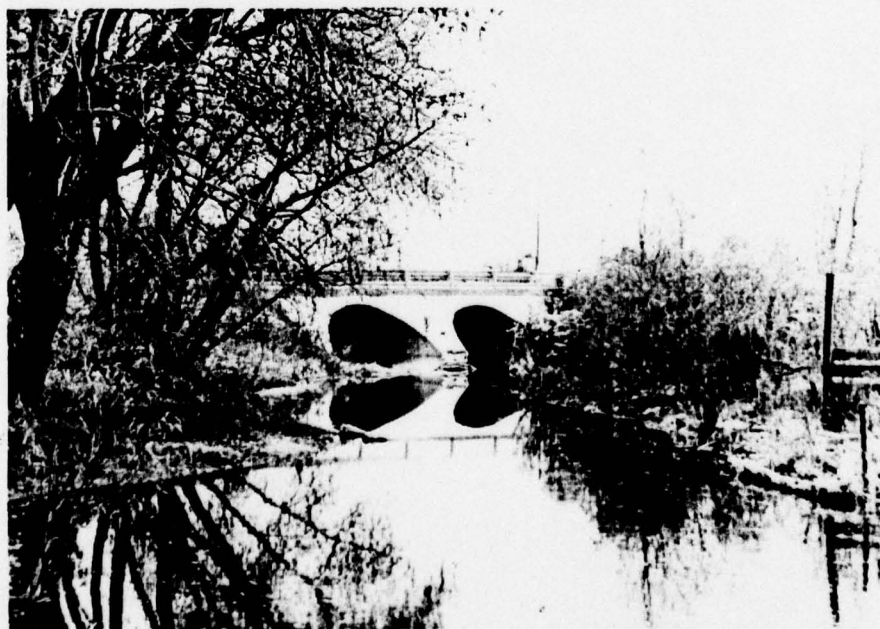
PHOTO 16

- Photo 15 - View of the downstream Mill Road Dam Channel.
Note: The eroded condition and the partially corrective measures.
- Photo 16 - View of the Rt. 195 culverts (partial) showing two of the three inlets under Rt. 195. Shot taken from the downstream Mill Race Channel.

View of Route 195 Culverts From
Mill Race Channel

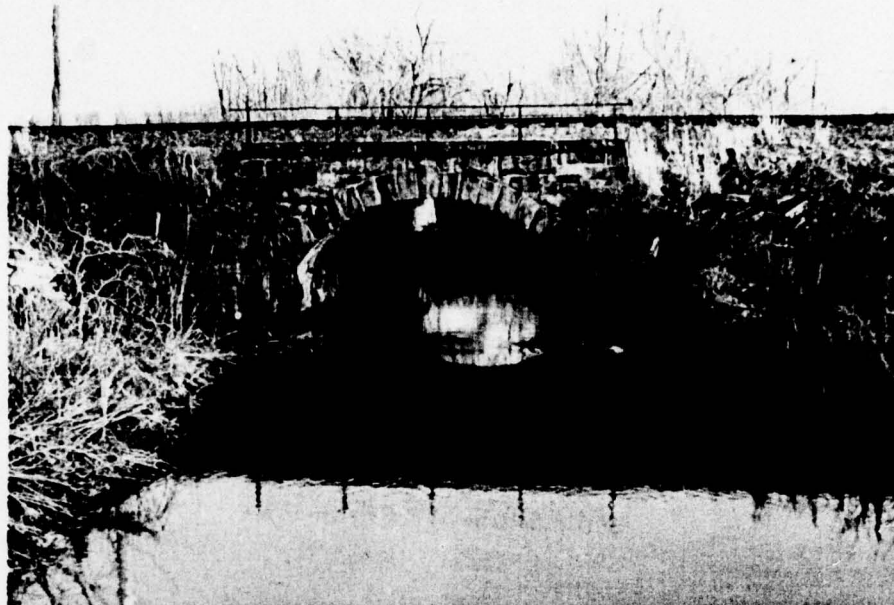
PHOTO 17
Pennsylvania Railroad Arch
Culvert

- Photo 17 - Upstream of The Pennsylvania R.R. arched stoned culvert. View of the channel and culvert taken from a location between the Rt. 195 culverts and the railroad.
